Maintaining a Stable Environment: *Vasa's* New Climate-Control System

An extensive upgrade to the air-conditioning system of the *Vasa* Museum in Stockholm is playing an instrumental role in preserving the seventeenth-century Swedish warship *Vasa*.

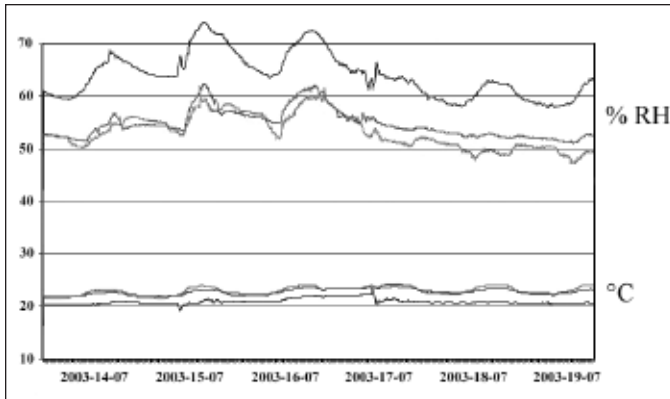
Fig. 4. An example of the fluctuating temperature and RH taken from three sensors on the ship in July 2003.

sulfate salts, predominantly yellow in color.⁵ The volume increase of the salts as they crystallize has caused the surface of the wood to spall off in places, resulting in the loss of surface detail on carved elements. Although it is likely that these processes had begun after the ship was raised, the results became particularly apparent after the wet summer of 2000, which, combined with large numbers of visitors, saw dramatic fluctuations in the RH. An example of the museum climate from July 2003 taken from the climate sensors onboard the ship shows the RH at some points lower down on the ship hull rise above 70% and then drop by 10% overnight (Fig. 4).

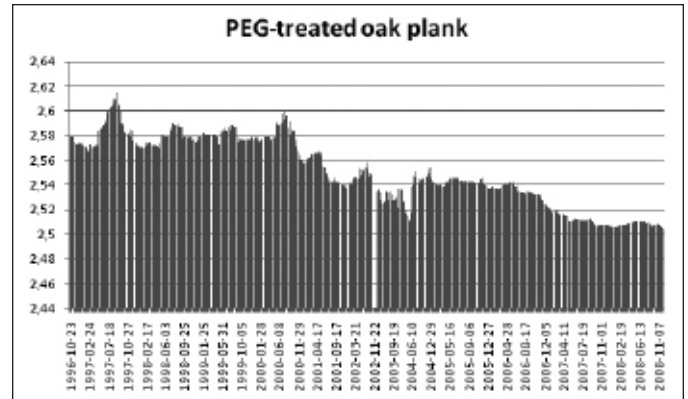
Fig. 5. Weight fluctuation in kg of an oak plank impregnated with polyethylene glycol that has been stored on board the ship since 1996.

Once moisture was identified as a problem, it was decided that the average RH in the exhibit hall should be reduced from 60% to 55%. The ship continues to dry out and is only now approaching a stable condition. Much of this climate history can be seen from the weight fluctuation of a PEG-treated oak timber from *Vasa*, which has been stored on one of the lower decks since 1996 (Fig. 5).

One of the clear consequences of a more stable climate has been seen in the salt-outbreak problem on the ship: since 2004 no major new outbreaks have been identified, and the pH of the existing precipitations has stabilized, strongly indicating that major moisture movement has been abated. This is clearly a positive effect for *Vasa's* wood chemistry and, due to the size of the ship, likely the only practical measure that can be taken in the short term to treat the outbreaks. From a structural viewpoint, the semi-annual geodetic measurement of the hull form has not shown the large seasonal movements exhibited with the older climate system, and less work is required to adjust the wedges between the hull and the support cradle. If structural movement can be minimized, it will assist greatly in the planning of a better support system. The ship continues to dry out, as can be seen from the weight change in the PEG-treated plank in Figure 5, probably due to the increased airflow established with the new

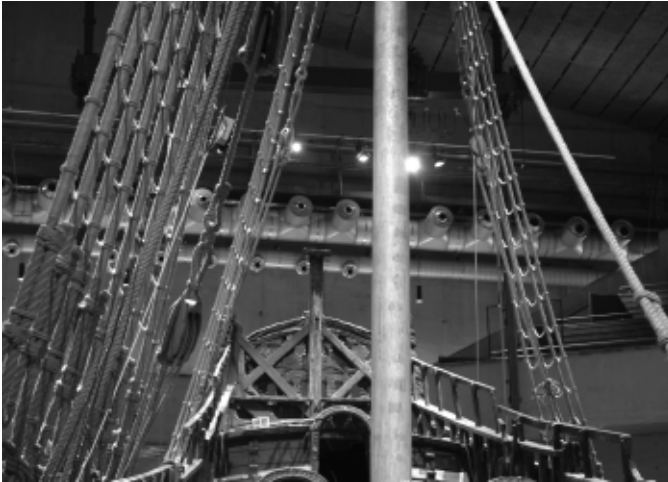
Fig. 7. Ducting at the stern of the ship, part of auxiliary plant CA03. Photograph by the author.

To combat problem areas in the museum, auxiliary systems have also been installed. As visitors tend to congregate to look at the sculptures adorning the stern, a second plant, CA02, delivers conditioned air through small slits located in the walls of the visitor galleries on levels four and six, and ducts high on the south wall of the museum above the stern are connected to plant CA03 (Fig. 7). Controlled by nearby sensors on the ship, these plants are designed to remove extra moisture. Since the ship does not sit at the center of the museum, there is consequently a huge volume of air on the port side. Plans to include air-conditioning in this area were struck from the 1980s designs

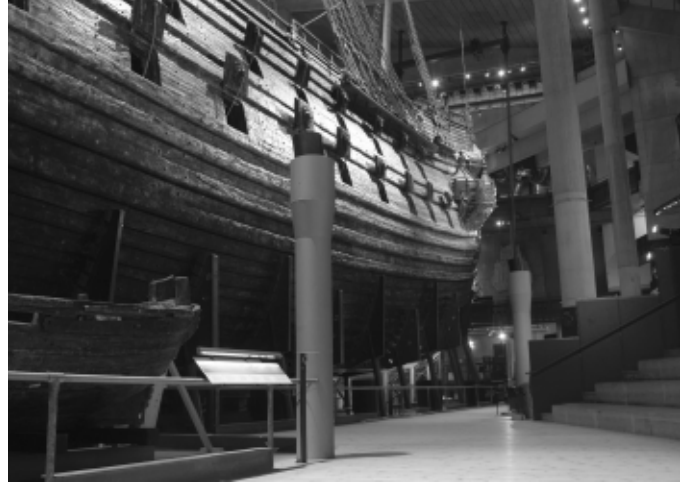
Fig. 8. Auxiliary vertical ducting on the port side of the hull. Photograph by the author.

for reasons of cost, but with the latest upgrade, six columns 11 ft. 6 in. (3.5m) high connected to CA01 have now been installed in this area; they are guided by sensors on the port side of the ship. These columns are capable of distributing conditioned air to a height of 52 ft. 6 in. (16 m) to create a “climate umbrella” around the hull (Fig. 8).

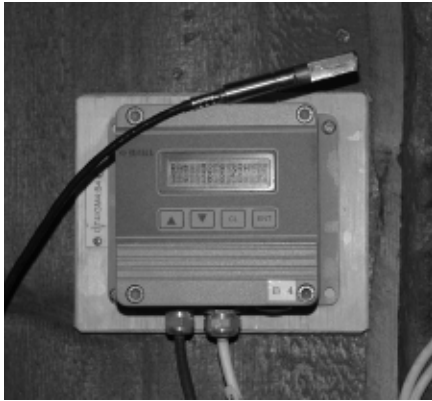
revealed to be reading 3% too low about 6 months after installation. The manufacturer's theory was that due to the unique chemical composition of wood in the *Vasa*, "unknown substances" were saturating the sensor membranes and distorting the readings. Although air samples and samples of the membrane were sent for analysis, the results were inconclusive, as the manufacturer was unwilling to reveal the full chemical composition of the membrane. This predicament has been solved by investment in a portable sensor with a chemical purge function; that is, the sensor may be heated to 320°F (160°C) for 2 minutes to burn off any built-up deposits on the membrane that might reduce its ability to absorb water molecules and reduce its sensitivity. This portable sensor is sent annually for calibration. Each spring before the peak tourist season, all sensors on the ship are individually adjusted to match the newly calibrated portable sensor, which is chemically purged each morning. The landlord then uses the same sensor to calibrate those in the plant. This solution avoids the impractical and expensive alternative of sending all sensors to the manufacturer for annual calibration.

Fig. 9. On-board sensor and display box. Photograph by the author.

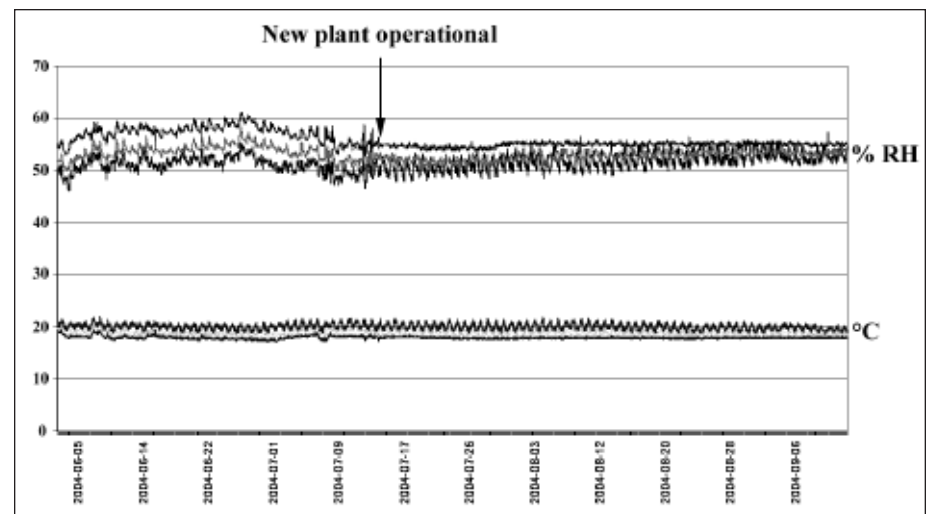
The new system came on line in May 2004 and was trimmed in July 2004 with visibly effective results (Fig. 10). The almost 10% RH gradient over the height of the ship was halved immediately, and by the end of summer 2004 the data curves appeared to be converging even more, averaging about 52 to 55% RH. Since 2004, efforts have been concentrated on fine-tuning the guidance parameters, both to improve energy efficiency and to achieve the best balance of factors for the ship; for example, adjusting the balance between the humidifiers, de-humidifiers, cooling units, and distribution fans. At first, sensors near the bottom of the ship, where freshly conditioned air emerges, were chosen to guide the main plant; however, a better overall climate has now been achieved by changing two of these primary sensors for two halfway up the hull, which are more sensitive to ambient changes in museum climate. There is still a tendency in summer months for the RH and temperature bands to spread in reaction to higher external temperatures and greater numbers of visitors, but these data still fall within acceptable levels and are appre-

Fig. 10. Temperature and RH readings during summer 2004, when the new climate-control system became operational.
