Maintaining a Stable Environment: *Vasa's* New Climate-Control System

An extensive upgrade to the air-conditioning system of the *Vasa* Museum in Stockholm is playing an instrumental role in preserving the seventeenth-century Swedish warship *Vasa*.

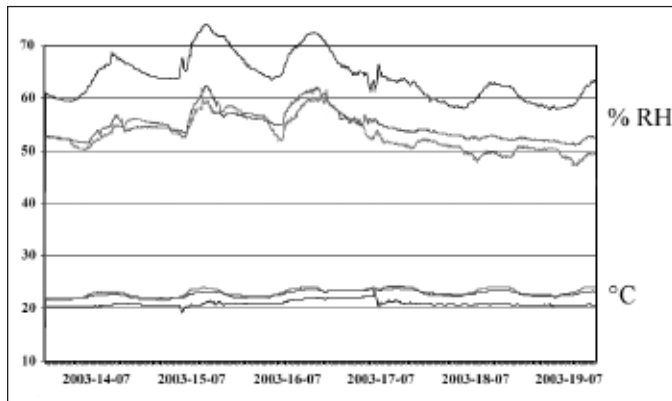
Fig. 4. An example of the fluctuating temperature and RH taken from three sensors on the ship in July 2003.

sulfate salts, predominantly yellow in color.⁵ The volume increase of the salts as they crystallize has caused the surface of the wood to spall off in places, resulting in the loss of surface detail on carved elements. Although it is likely that these processes had begun after the ship was raised, the results became particularly apparent after the wet summer of 2000, which, combined with large numbers of visitors, saw dramatic fluctuations in the RH. An example of the museum climate from July 2003 taken from the climate sensors onboard the ship shows the RH at some points lower down on the ship hull rise above 70% and then drop by 10% overnight (Fig. 4).

east wall near the ceiling (Fig. 3) and returned to the plant, where it was filtered, dehumidified, and cooled to about 45°F (9°C). For visitor comfort, about 30% outdoor air was included in the conditioned air, which was then redirected into the museum. Onboard the ship an internal air-distribution system, with air exchange of 247,200 ft.³/h (7,000 m³/h), was adapted from the ducting used during the post-conservation drying. When the museum opened in 1990, specifications of 60% RH and 68°F (20°C) were set for summer months, and 57% RH and 62°F (17°C) in winter to reduce the risk of condensation in the walls of the building.⁶ These values corresponded to a target moisture content in the wood of 10 to 12%. Temperature and RH were recorded every 10 minutes through 21 permanently mounted sensors (17 on the exterior and 4 on the interior of the ship) and 10 portable sensors. The basic principle of this system was to distribute conditioned air by convection and thus avoid causing uneven drying of the wood through fan-assisted circulation. The temperature and corresponding RH gradients caused by the building height were accepted as inevitable. In practice, however, the system was under-dimensioned and too often ran at full capacity. The RH targets were frequently exceeded, and data typical of those seen in Figure 4 were regularly recorded.

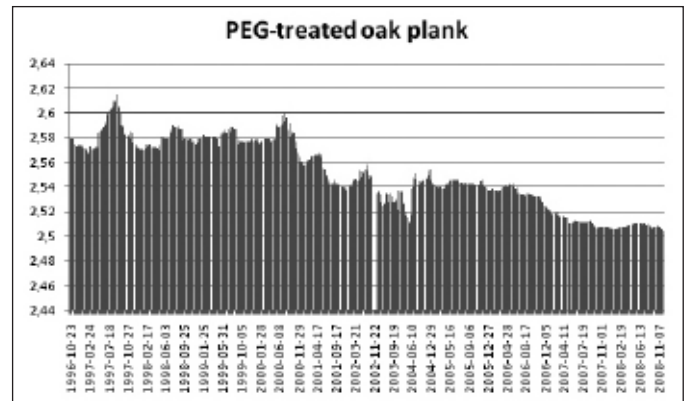
Fig. 5. Weight fluctuation in kg of an oak plank impregnated with polyethylene glycol that has been stored on board the ship since 1996.

Once moisture was identified as a problem, it was decided that the average RH in the exhibit hall should be reduced from 60% to 55%. The ship continues to dry out and is only now approaching a stable condition. Much of this climate history can be seen from the weight fluctuation of a PEG-treated oak timber from *Vasa*, which has been stored on one of the lower decks since 1996 (Fig. 5).

One of the clear consequences of a more stable climate has been seen in the salt-outbreak problem on the ship: since 2004 no major new outbreaks have been identified, and the pH of the existing precipitations has stabilized, strongly indicating that major moisture movement has been abated. This is clearly a positive effect for *Vasa's* wood chemistry and, due to the size of the ship, likely the only practical measure that can be taken in the short term to treat the outbreaks. From a structural viewpoint, the semi-annual geodetic measurement of the hull form has not shown the large seasonal movements exhibited with the older climate system, and less work is required to adjust the wedges between the hull and the support cradle. If structural movement can be minimized, it will assist greatly in the planning of a better support system. The ship continues to dry out, as can be seen from the weight change in the PEG-treated plank in Figure 5, probably due to the increased airflow established with the new

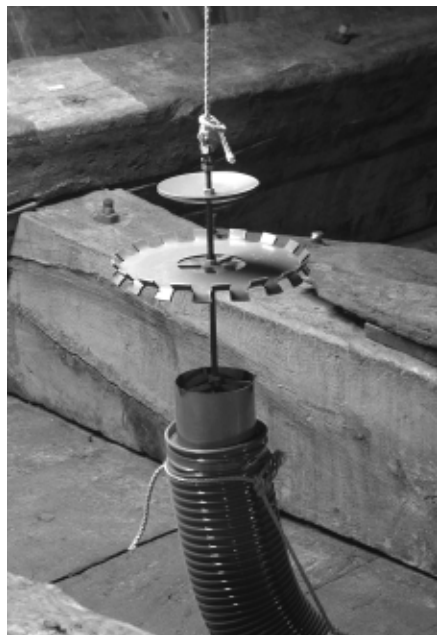
Fig. 6. Specially designed duct heads used to provide efficient distribution of climatized air inside the ship. Photograph by the author.

was also concentrated. Smoke visualization tests showed that the airflow was uneven in the hull interior, especially on the lower decks, where pockets of higher RH were created, and that the ducting was in poor condition and leaking.⁷ Much of this information had been reinforced by the evidence of the salt outbreaks, which were more numerous and exhibited lower pH levels in areas exposed to higher or fluctuating RH levels.⁸ The design and capacity of the air-conditioning system were also examined, as were the effectiveness of the supply ducts and the location of sensors for controlling and monitoring the climate. Computer simulations using computational fluid dynamics analyzed the effects produced by evening events or banquets and times of maximum load to the system, for example in July and August, when visitor numbers are highest and maximum dehumidification is required.

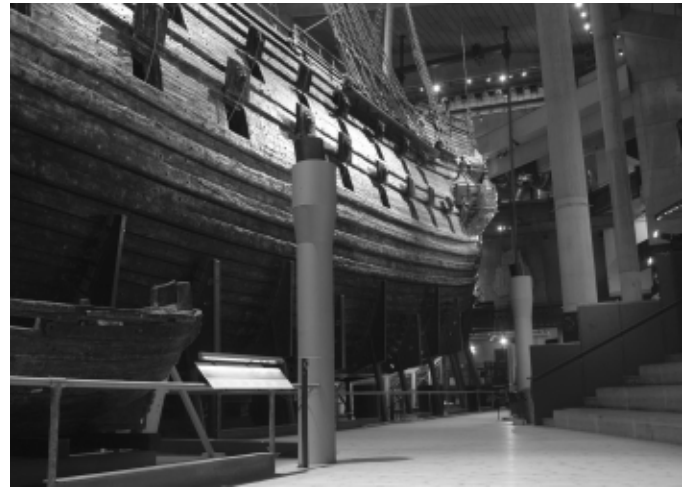
To combat problem areas in the museum, auxiliary systems have also been installed. As visitors tend to congregate to look at the sculptures adorning the stern, a second plant, CA02, delivers conditioned air through small slits located in the walls of the visitor galleries on levels four and six, and ducts high on the south wall of the museum above the stern are connected to plant CA03 (Fig. 7). Controlled by nearby sensors on the ship, these plants are designed to remove extra moisture. Since the ship does not sit at the center of the museum, there is consequently a huge volume of air on the port side. Plans to include air-conditioning in this area were struck from the 1980s designs

Fig. 8. Auxiliary vertical ducting on the port side of the hull. Photograph by the author.

for reasons of cost, but with the latest upgrade, six columns 11 ft. 6 in. (3.5m) high connected to CA01 have now been installed in this area; they are guided by sensors on the port side of the ship. These columns are capable of distributing conditioned air to a height of 52 ft. 6 in. (16 m) to create a “climate umbrella” around the hull (Fig. 8).

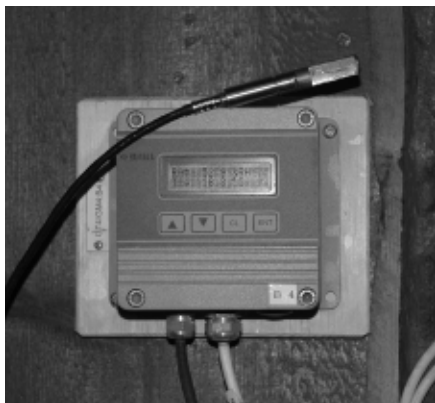
revealed to be reading 3% too low about 6 months after installation. The manufacturer's theory was that due to the unique chemical composition of wood in the *Vasa*, "unknown substances" were saturating the sensor membranes and distorting the readings. Although air samples and samples of the membrane were sent for analysis, the results were inconclusive, as the manufacturer was unwilling to reveal the full chemical composition of the membrane. This predicament has been solved by investment in a portable sensor with a chemical purge function; that is, the sensor may be heated to 320°F (160°C) for 2 minutes to burn off any built-up deposits on the membrane that might reduce its ability to absorb water molecules and reduce its sensitivity. This portable sensor is sent annually for calibration. Each spring before the peak tourist season, all sensors on the ship are individually adjusted to match the newly calibrated portable sensor, which is chemically purged each morning. The landlord then uses the same sensor to calibrate those in the plant. This solution avoids the impractical and expensive alternative of sending all sensors to the manufacturer for annual calibration.

Fig. 9. On-board sensor and display box. Photograph by the author.

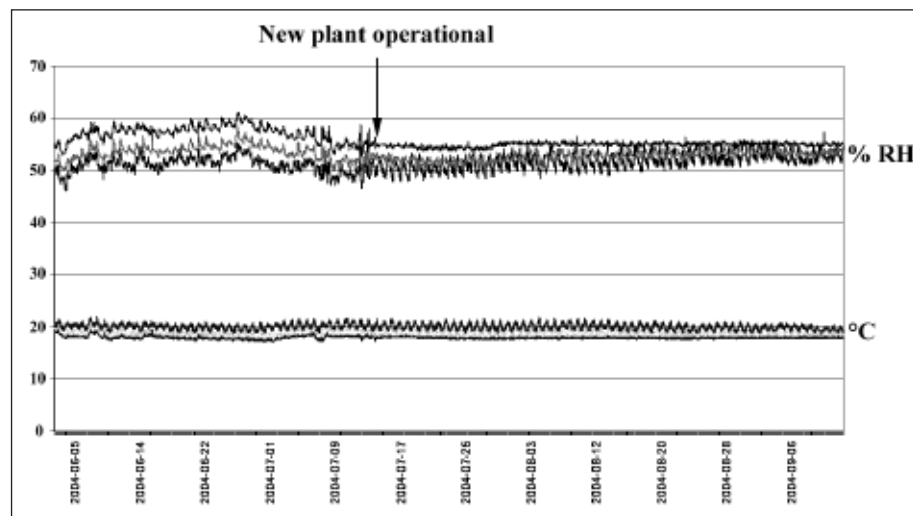
The new system came on line in May 2004 and was trimmed in July 2004 with visibly effective results (Fig. 10). The almost 10% RH gradient over the height of the ship was halved immediately, and by the end of summer 2004 the data curves appeared to be converging even more, averaging about 52 to 55% RH. Since 2004, efforts have been concentrated on fine-tuning the guidance parameters, both to improve energy efficiency and to achieve the best balance of factors for the ship; for example, adjusting the balance between the humidifiers, de-humidifiers, cooling units, and distribution fans. At first, sensors near the bottom of the ship, where freshly conditioned air emerges, were chosen to guide the main plant; however, a better overall climate has now been achieved by changing two of these primary sensors for two halfway up the hull, which are more sensitive to ambient changes in museum climate. There is still a tendency in summer months for the RH and temperature bands to spread in reaction to higher external temperatures and greater numbers of visitors, but these data still fall within acceptable levels and are appre-

ciably better than in previous summers. Indeed, the system has functioned so well that the average RH for the rest of the year is now $53 \pm 2\%$ at all parts of the ship. Daily RH fluctuations at any sensor are reduced to around $\pm 2\%$, helped in 2008 by the introduction of more energy-efficient lighting in the museum.

Fig. 10. Temperature and RH readings during summer 2004, when the new climate-control system became operational.
