Nord Stream 2

Archaeological analysis of geophysical data

Baltic Sea Swedish EEZ

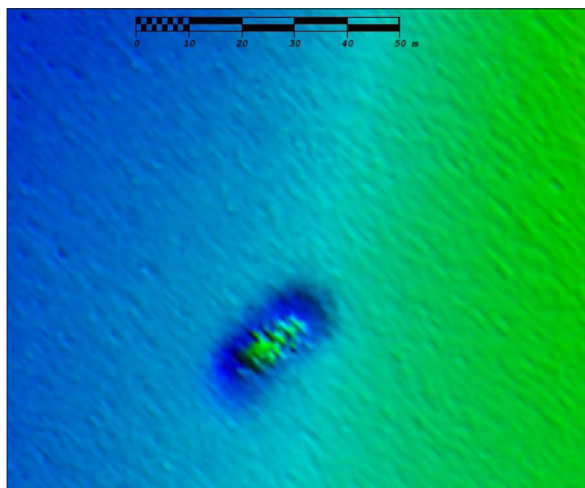
Fig. 4. Sonar image of wreck S-R17-4285 © Swedish Maritime Administration.

The wreck S-R17-4285 was found by the Swedish Maritime Administration in 2009. This is a 20 meter long wreck and according to the sonar image the wreck seems to be intact. On basis of the sonar image it's impossible to tell if it has foundered before 1850.

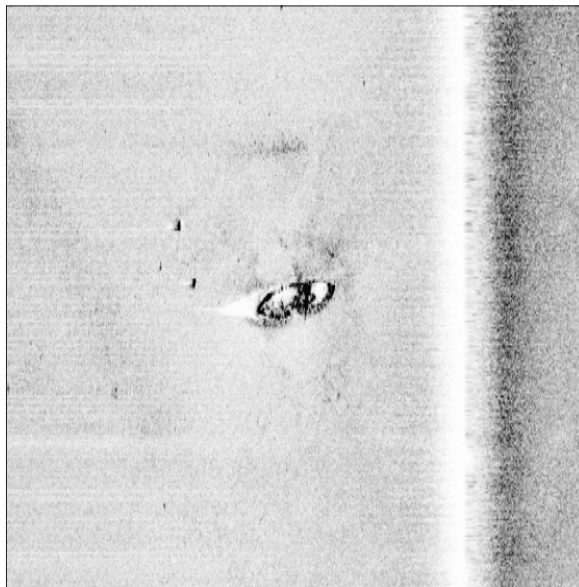
Fig. 7. Sonar image of wreck S-R19-1026 © Fugro.

This indication is interpreted as an 18 meter long wreck, but based on the sonar image it is impossible to tell if it has foundered before 1850. It might be a wooden wreck and therefore a possible cultural monument. According to the sonar image the wreck seems to be relatively intact.

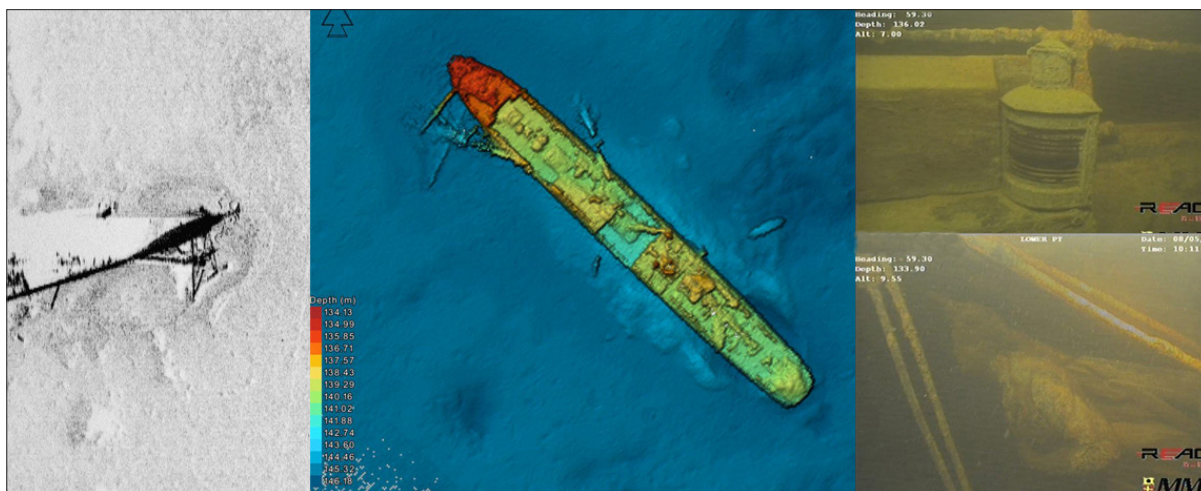
This is an 81 meter long and 9 meter wide wreck. MMT has done a ROV-filming and bathymetry survey of the wreck. The ROV-pictures shows that the wreck appears to be made of steel, with iron rails, navigations lights of metal with "fresnel lens", lifeboats with lifting hooks of iron and a figurehead (fig. 11). MMT interprets it as an old steamer from the early 20th century (MMT 2016a) and it might be so. The details and the size, length/width ratio (1/9) indicates that it could be

Fig. 11. Sonar image, multibeam image and photos of port navigation light and bow figure head at S-R24-5317 © Fugro and MMT.

a bark ship built around 1900, possibly foundered around the 1st or 2nd world war. Traditional steamers were usually wider and did not have figure-heads as often as sail ships.

The size and the details, like the navigation light suggest that the wreck has foundered in the early 20th century, but if it is deemed as of special value it might be considered as a cultural monument by the county administrative board. According to the sonar image the wreck seems to be relatively intact except the associated debris (S-R24-5318 and S-R24-5389) near the wreck.

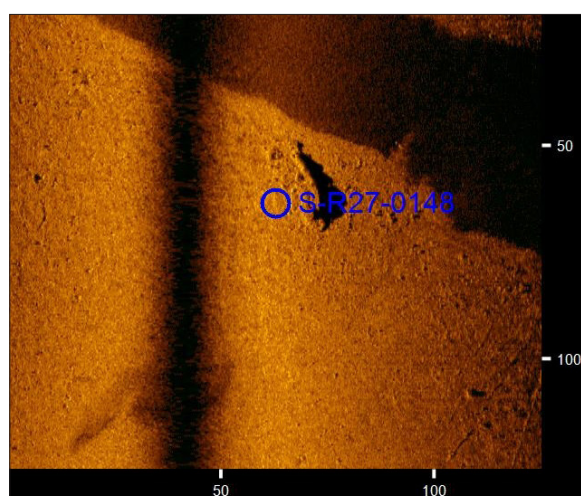
This indication is classified as a possible wreck by SMM and Fugro's has classified it as a "mound".

Fig. 14. Sonar image of possible wreck S-R27-0148 © Fugro, edited by Mikael Fredholm, Maritime Museum.

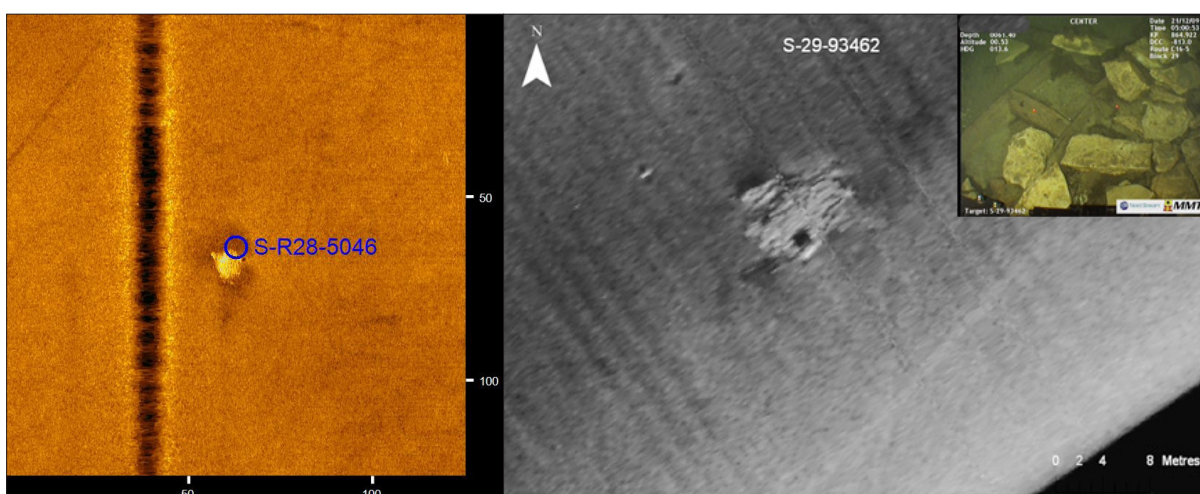
S-R28-5047 and S-R28-5046

The indications are the same as Nord Stream indication S-29-93462. This is a clinker built wooden wreck with ballast/cargo of limestones and iron. It is a cultural monument, possibly a medieval ship (Fredholm 2010: page 27) and the wreck corresponds to the definitions in the Swedish Heritage Conservation Act (1988: 950) as a cultural monument. The main wreck area is concentrated

Fig. 17. Sonar image and ROV-photo of wreck S-R28-5046/5047 (S-29-93462) © Fugro and MMT, edited by Mikael Fredholm, Maritime Museum.

except an associated container approximately 30 meters southeast of the wreck and a ship timber 15 meter northwest of the wreck. The wreck area is around 30×30m (Nord Stream, 2009).

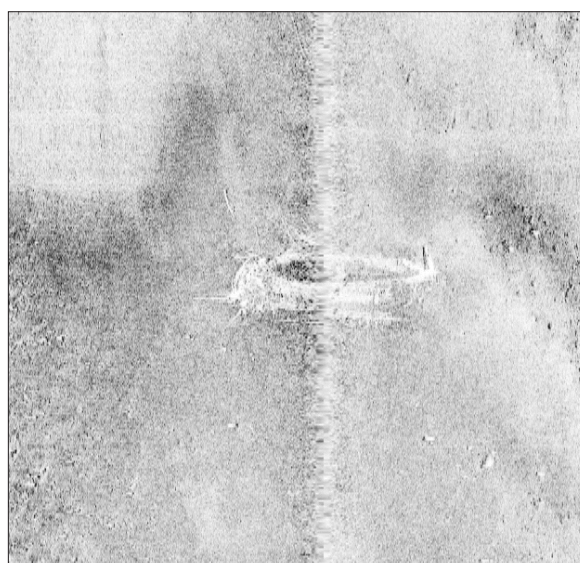
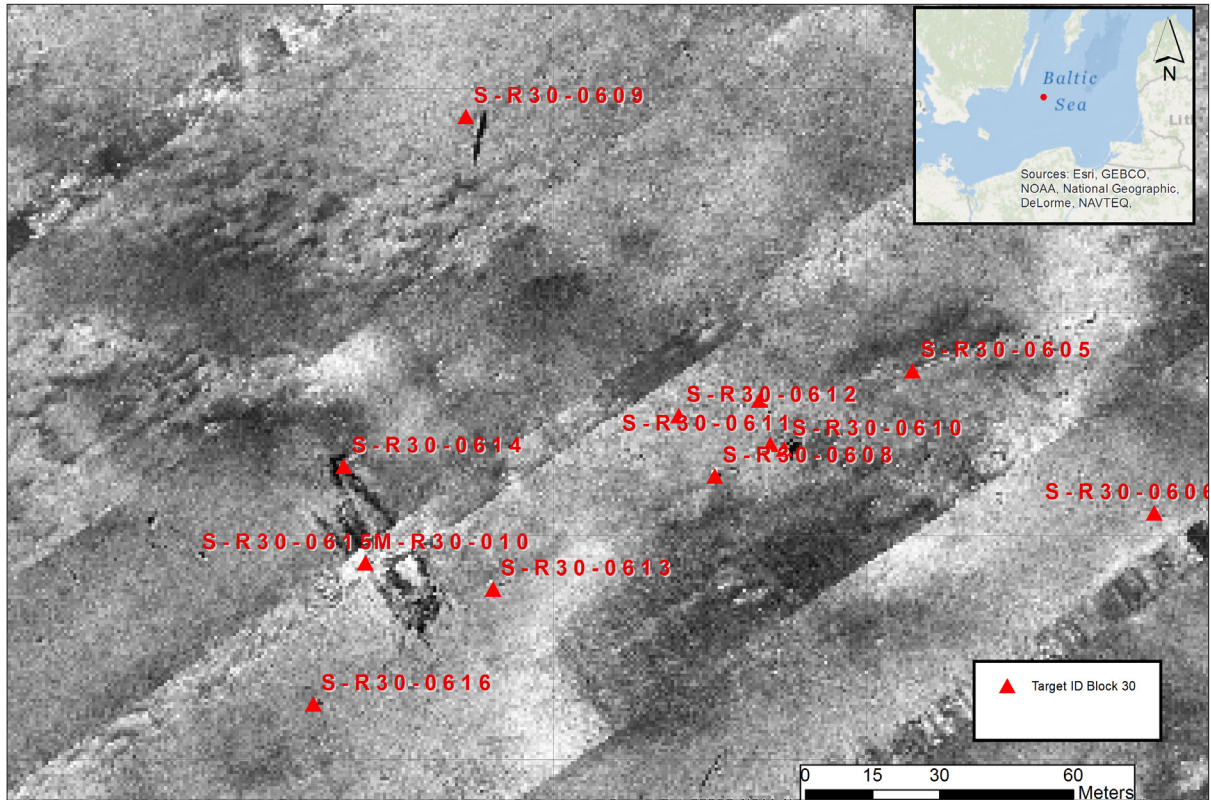
Fig. 20. Sonar image of wreck S-R30-0615 © Fugro.

Fig. 21. Sonar mosaic map over the area around wreck S-R30-0615. © ESRI and Fugro, edited by Mikael Fredholm, Maritime Museum.

S-R30-2737 has in total 22 sonar indications of possible wreck debris.

Until the status of all the possible wreck debris is clear (i.e. ROV-inspection) SMM recommend an offset of 50 meter to each indication. Based solely on the sonar images it is not certain that all “wreck debris” are from the same wreck. It could well be pieces of several wrecks.

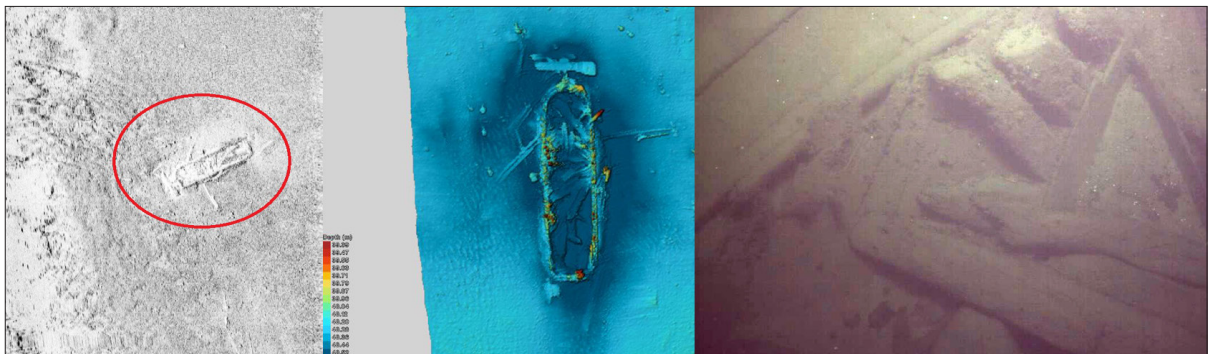
Fig. 22. Sonar image, multibeam image and photo of S-R30-0997 a © Fugro, MMT, MMT.

This is 24 meter long wreck. According to the sonar image the wreck seems to be relatively intact and no wreck debris scattered more than 50 meter away from the wreck. It does not seem to be any trawl scars close to the wreck. MMT has done a ROV

and bathymetry survey of the wreck. The ROV-pictures shows clearly that it is a wooden wreck (MMT 2016b) but the still images provided in the report is not enough for an exact dating of the wreck. The wreck seems to be carvel built with inner planking and is probably a cargo ship. The possible stern is located to the north and the bathymetry shows an

object outside the hull that could be the rudder (fig. 22). The size and shape (bathymetry) of the wreck is similar to the investigated fluit ship Jutholmsvraket from around 1700 (Eriksson 2010), but it might also be a galiot from 18–19th century, that also had similar shapes like the fluit ships. The degree of composition also indicates that the wreck is likely to

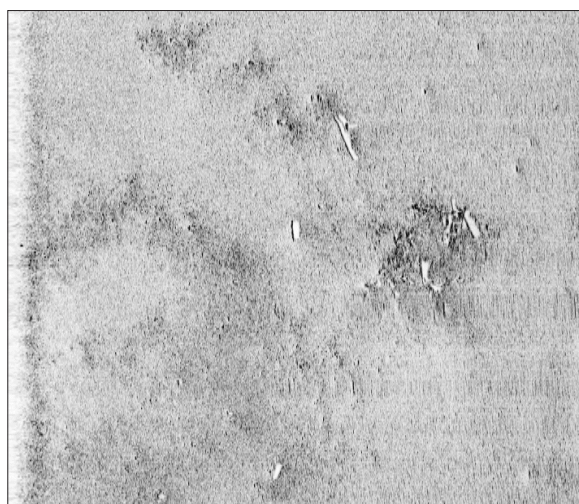
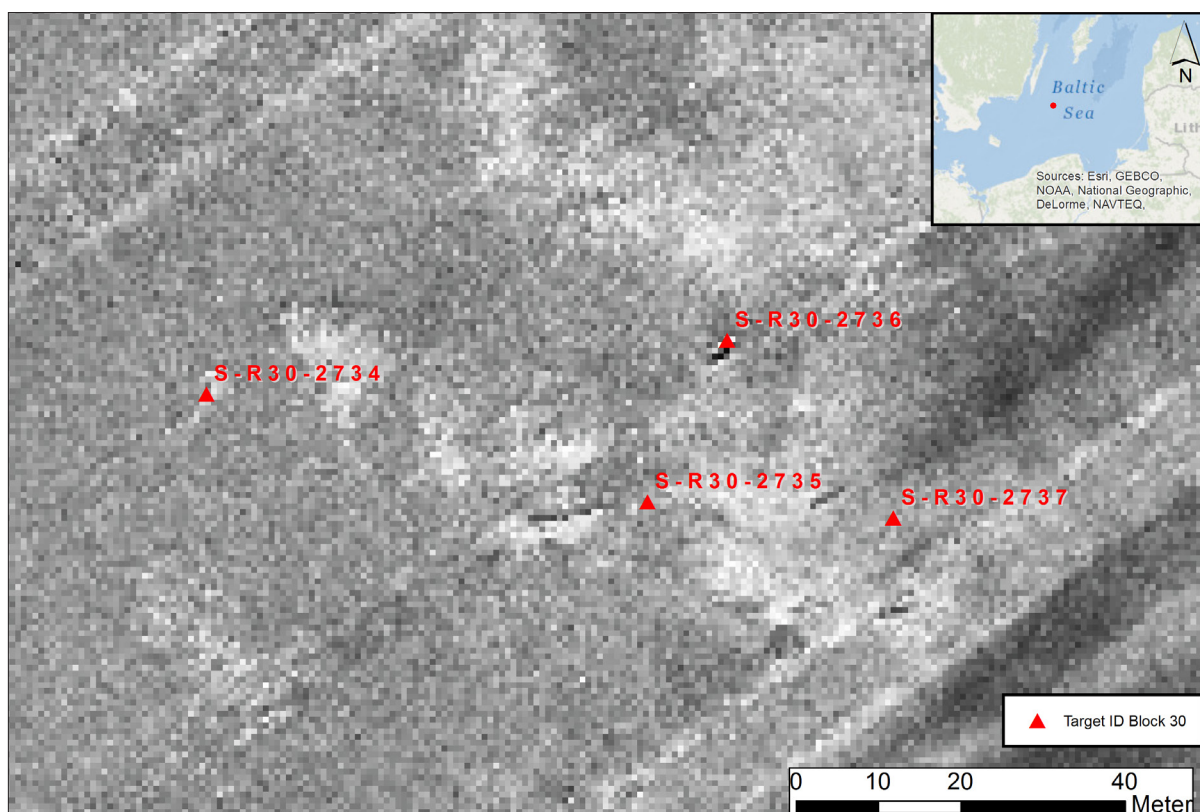
Fig. 24. Sonar image of wreck indication S-R30-2737 and possible debris © Fugro.

Fig. 25. Sonar mosaic map over the area around wreck S-R30-2737. © ESRI and Fugro, edited by Mikael Fredholm, Maritime Museum.

This is probably a broken wreck with indications of wreck debris (S-R30-2734, S-R30-2735 and S-R30-2736). It is probably a wooden wreck and therefore a possible cultural monument. According to the sonar image the wreck seems to have associated debris close by and scattered up to around 100 meters away from the actual wreck (see fig. 25). 80 meters to southwest is indication S-R30-3018, that might be another wreck or parts of the same wreck as S-R30-2737. Based solely on the sonar images it's not certain if all "wreck debris" are from the same wreck, it could as well be pieces of one or more wrecks. Before the status of all the possible debris is clear (i.e.

ROV-inspection) SMM recommend an offset of 50 meter to each indication.

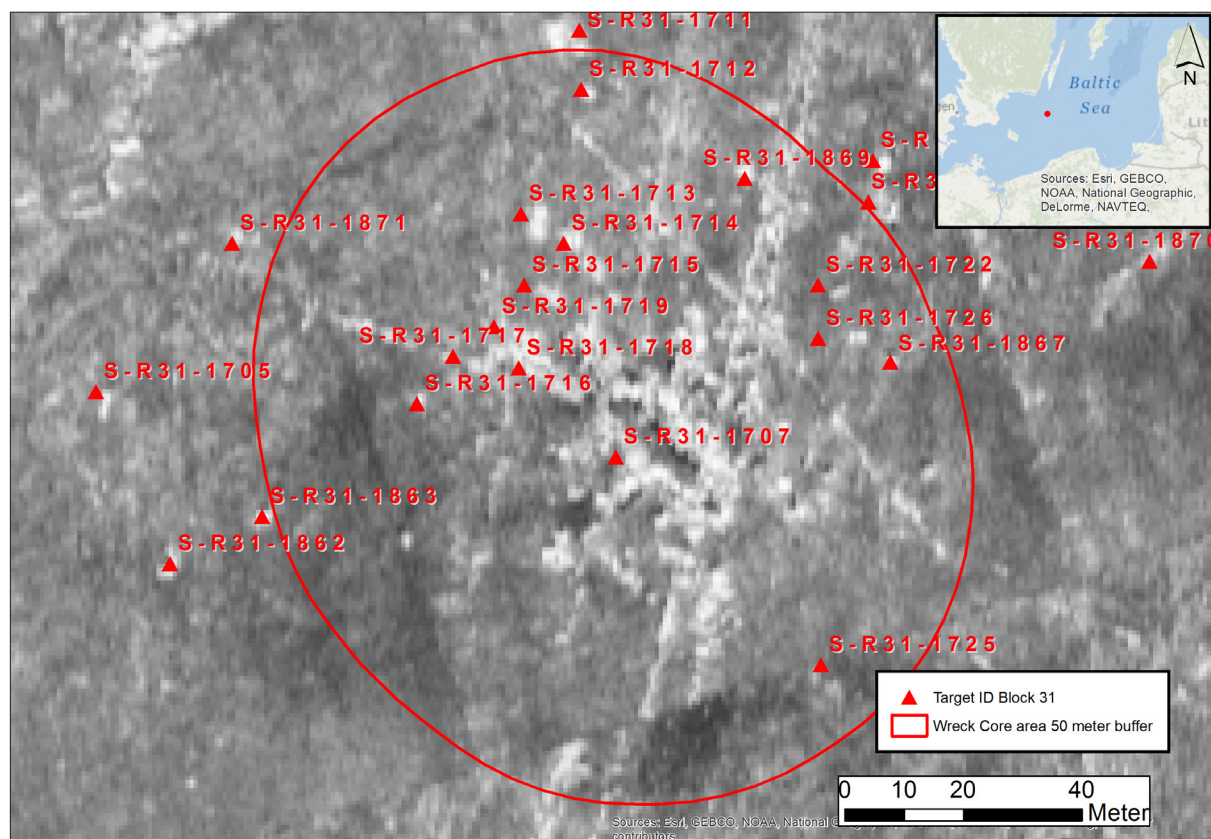
This is the wreck R32-92558 from Nord Stream (Fredholm 2010: page 29) but the wreck is now called S-R31-1707 by Fugro. Associated wreck de-

Fig. 28. Sonar image of wreck S-R31-1707 and wreck debris around the indication. There are also travel scars in the bottom.
© Fugro.

bris are S-R31-1706 to S-R31-1726 and S-R31-1862 to S-R31-1872.

The earlier ROV documentation determined that it is a carvel-built vessel of wood. The wreck

Fig. 29. Sonar mosaic map over the area around wreck S-R31-1707. Core area is the in 2010 agreed 50 meter protection area. © ESRI and Fugro, edited by Mikael Fredholm, Maritime Museum.

is degraded and has probably been damaged by trawling. It is spread over an area of approximately 140 × 160 meter, but the main wreckage area is about 30 meters (NW–SE) × 15 meters (SO–NE). Among the wreckage it was possible to discern

some bottles – one could be dated to the period 1720–1750 and one to 1720–1780. The windlass has a carved wreath and is typologically dated to

18th century, same as the bottles. Everything indicates that the ship have foundered in the 18th century (Fredholm 2010: page 29). The wreck corresponds to the definitions in the Swedish Heritage Conservation Act (1988: 950) as a cultural monument. In 2010 after the ROV-inspections Nord Stream and SMM agreed to protect a 50 meter core area of the wreck S-R31-1707 (R-32-92558) as shown in fig. 29. This is now SMM's proposed offset to the pipeline.

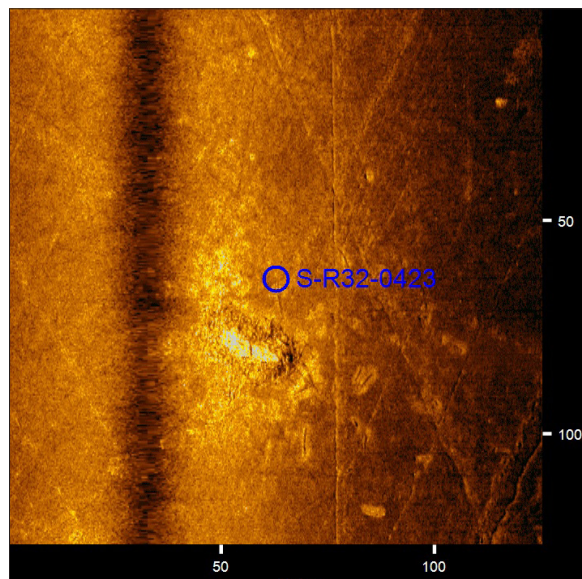
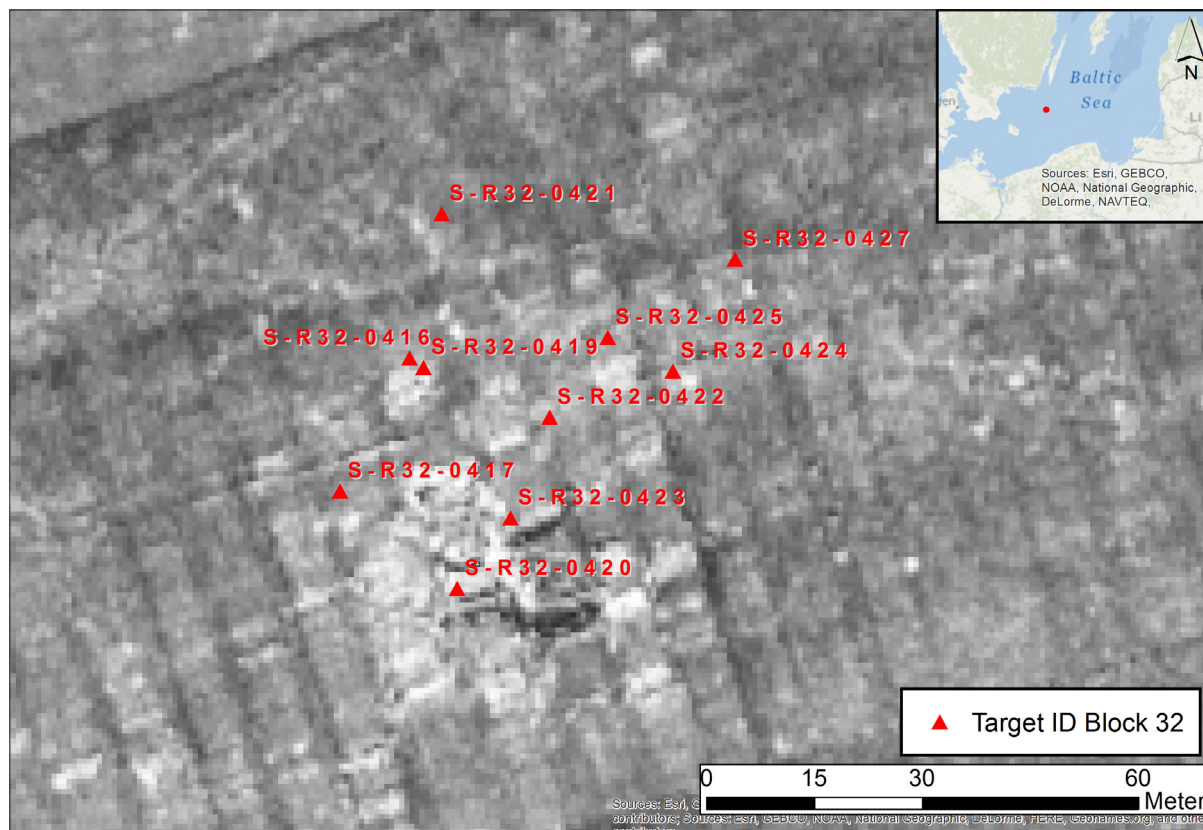
Fig. 31. Sonar image of wreck S-R32-0423 and possible wreck debris around the indication. There are also trawl scars in the bottom. © Fugro, edited by Mikael Fredholm, Maritime Museum.

Fig. 32. Map over the area around wreck S-R32-0423 and the possible wreck debris. © ESRI and Fugro, edited by Mikael Fredholm, Maritime Museum.

A wreck area with possible wreck debris S-R32-0416 to S-R32-0427 (fig. 32). Until the status of all the possible wreck debris is clear (i.e. ROV-inspection) SMM recommend an offset of 50 meter to each indication.

For the possible scattered wrecks like S-R30-3018 and S-R-32-0423 SMM suggest that the wrecks and the associated debris is ROV-inspected. If then the debris is concluded as not highly significant for the understanding and dating of the wrecks SMM might recommend a protected core area like for the wreck S-R31-1707 (R32- 92558 in 2010).
